IMPROVING THE DAMAGE TOLERANCE OF COMPOSITE JOINTS WITH TUFTING

James Kratz¹, Harry Clegg², Giuseppe Dell'Anno² and Ivana K Partridge¹

Keywords: 3D reinforcement, Damage tolerant joints, Automated manufacturing, Tufting

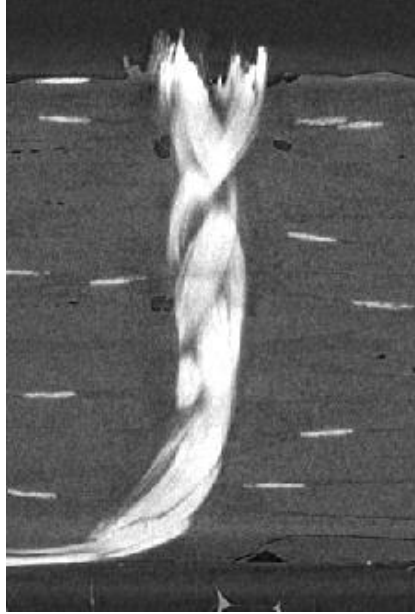
Figure 1: Micro-CT image of a glass tuft in a carbon fibre laminate (from [7]).

are available to reduce the manufacturing complexity. Tufting is such a single-sided process, whereby a single needle inserts a single dry thread into the reinforcement without tension. A disposable backing material is required on the other side of the preform to form the loops and prevent the thread from moving during needle retraction [6]. The tufted preform can be infused using traditional resin infusion methods, and the tufts (Figure 1) have been successful at arresting cracks and even recovering the load path in T-stiffened structures tested in pull-out [5].

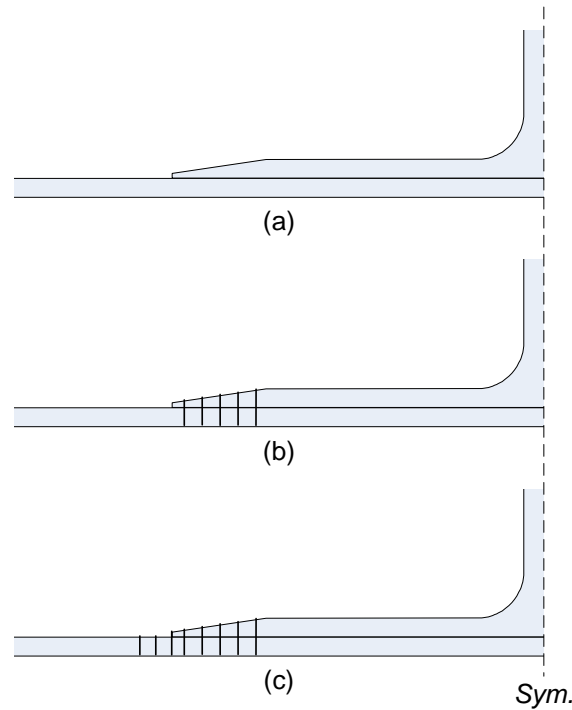
Figure 2: Specimen tufting configurations (a) untufted, (b) stringer transition, and (c) stringer transition and adjacent skin.

Specimens were tufted in two configurations to identify what trigger mechanisms cause crack initiation and subsequent propagation through a skin-stringer transition. A control specimen with no tufts was also manufactured and tested for comparison. Figure 2 shows the location and number of tufts in the stiffened panels. The skin was 8 mm thick and the flange 4 mm thick, with a stacking sequence of $[-45/45/90/45/-45/0]_{4S}$ and $[-45/45/90/45/-45/0]_{2S}$, respectively. The total thickness of the web was 8 mm. The transition between the skin and flange of the T-stiffener was manufactured by dropping plies every 2 mm, resulting in a 8.5° ramp, with a 1 mm step in the preform. This step was included to have one covering ply for every 4 dropped plies. The infusion tooling was manufactured without a step to ensure a smooth transition between the skin and flange, but a local resin rich region is expected.

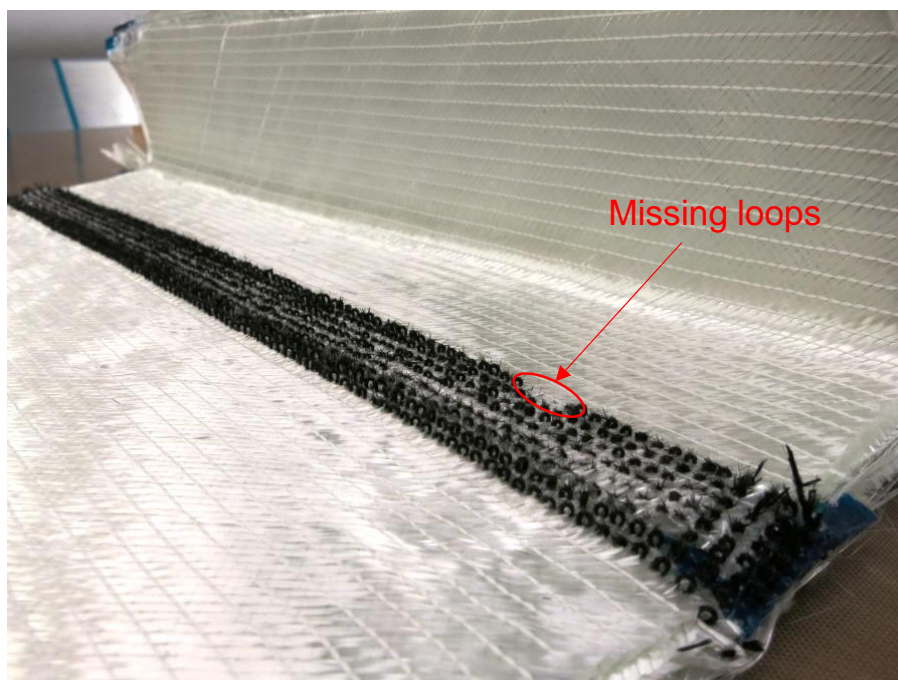
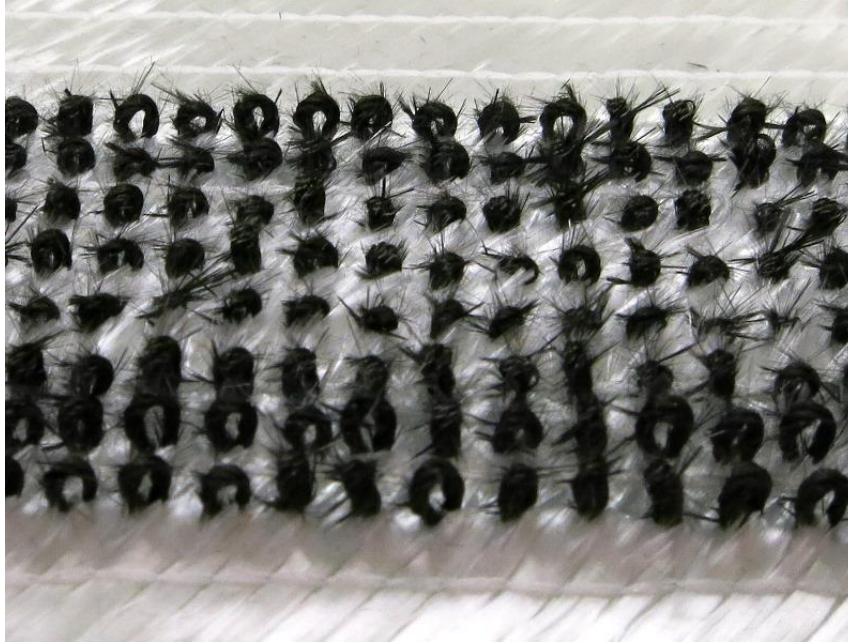
(a)

(b)

Figure 4: (a) carbon tufts in transition of the preform before infusion and (b) filament fragmentation in the loops.

Figure 4 shows the preform once the foam backing was removed, just prior to vacuum infusion. A few (3–4) loops were missing towards one end of the tufting seam (Figure 4a), and some variation in loop size was observed (Figure 4b), but overall full loops were formed during the tufting process. The bend radius of the loops caused some filament fragmentation in the thread (Figure 4b), and this cannot be avoided without moving to alternative tufting threads, such as stretch-broken or aramid [6].

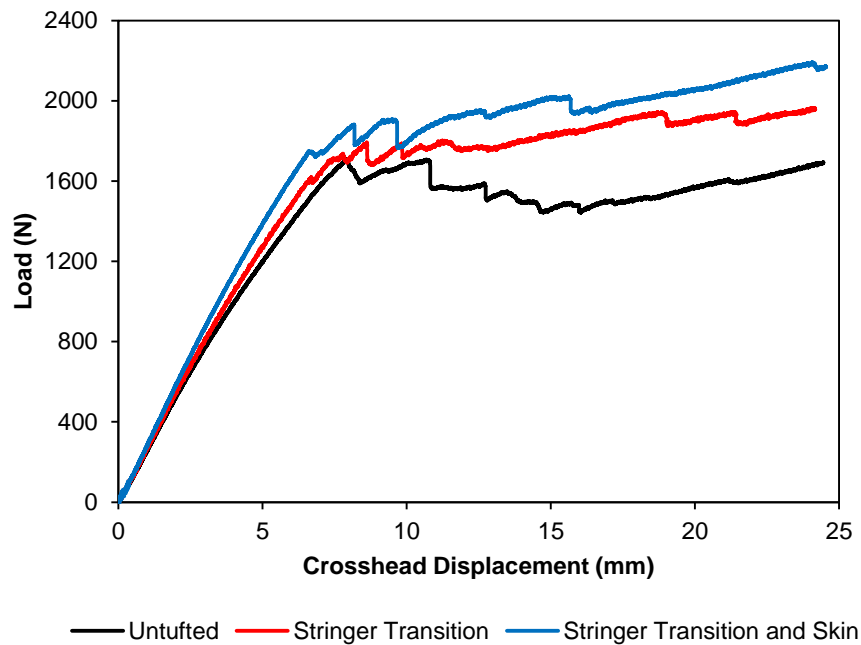
Figure 6: Typical load-displacement plot for the tufted skin-stringer bending tests.

Three specimens were tested for each tufting configuration. One specimen was tested until the joint was about to contact the baseplate of the flexural test fixture, meanwhile, the other two were tested to the first load drop to identify the crack initiation mechanisms. The results of the full-stroke bending test are shown in Figure 6. The untufted control specimen showed the lowest peak load before the onset of delamination. Tufting the stringer transition increased the stiffness of the skin-stringer joint, the onset delamination load, and the sustained damage load. Additional tufts inserted in the adjacent skin to the stringer tip had a similar improvement on performance compared to only tufting the stringer transition. Inserting the tufts clearly improved the damage tolerance as seen by the higher load levels required to propagate damage in the joint.

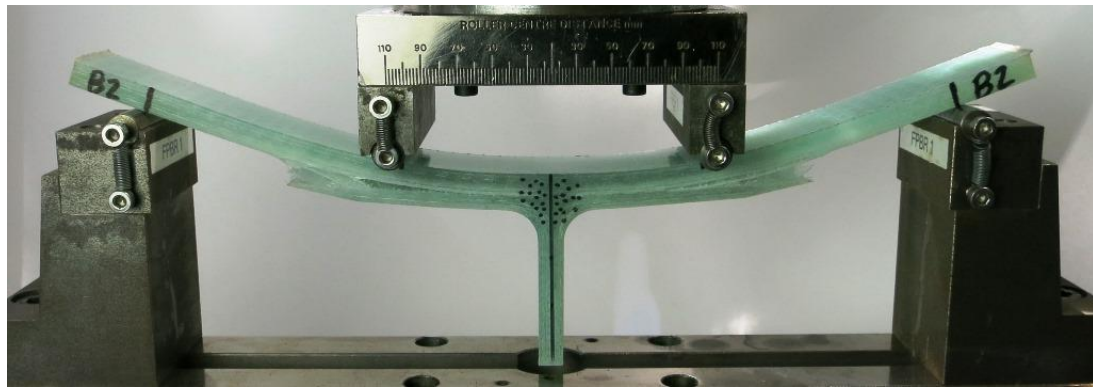
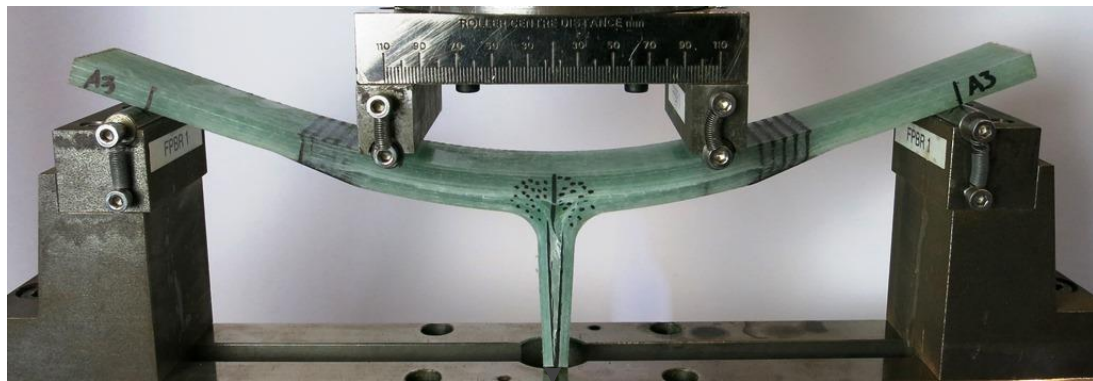
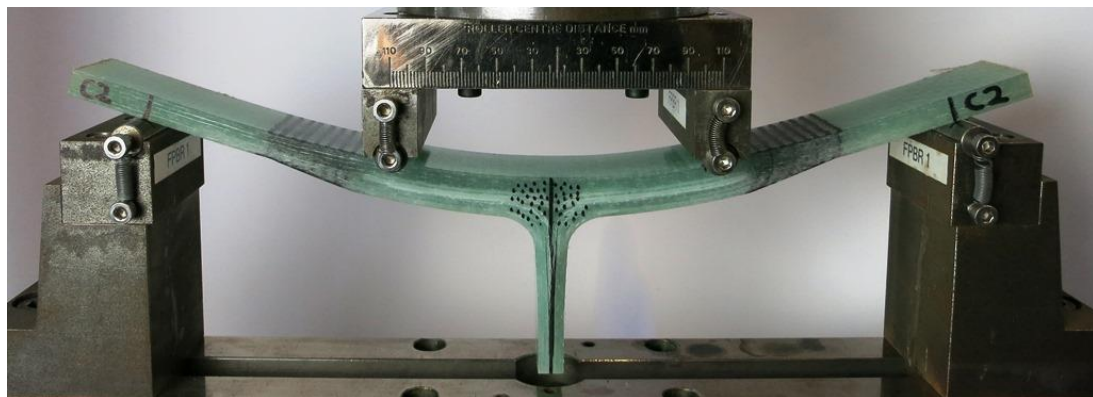
(a) Control

(b) Stringer transition tufted

(c) Stringer transition and skin tufted

Figure 7: Final failure modes observed in the skin stringer panels: (a) delamination originating from the stringer tip in the control specimen, (b) web-splitting and delamination in stringer flange, and (c) reduced web-splitting but delamination in stringer flange.

Photographs of the skin-stringer specimens at the end of full-stroke testing are shown in Figure 7. The untufted control specimen shows separation of the stringer from the skin. Once the peak load was reached, the stringer flange delaminated from the stringer tip, peeling towards the web as the crosshead continued to travel. The web remained intact as the damage is located between the stringer flange and skin of the joint. Delamination was again observed in the tufted specimens, but the failure mode was altered. Inserting tufts into the stringer transition prevented the flange from separating from the skin, but delamination was observed between the skin and stringer as a white crack in Figure 7b-c. Since the tufts retained contact between the skin and the stringer flange after delamination, the joint remained in contact and able to sustain load, as measured in Figure 6. Both tufted configurations change the failure mode from stringer tip separation from the skin to web splitting in the stringer. While tufting does increase the damage tolerance of the structure, identifying the trigger mechanisms that initiate delamination, and successful mitigation of these, was of greater interest.

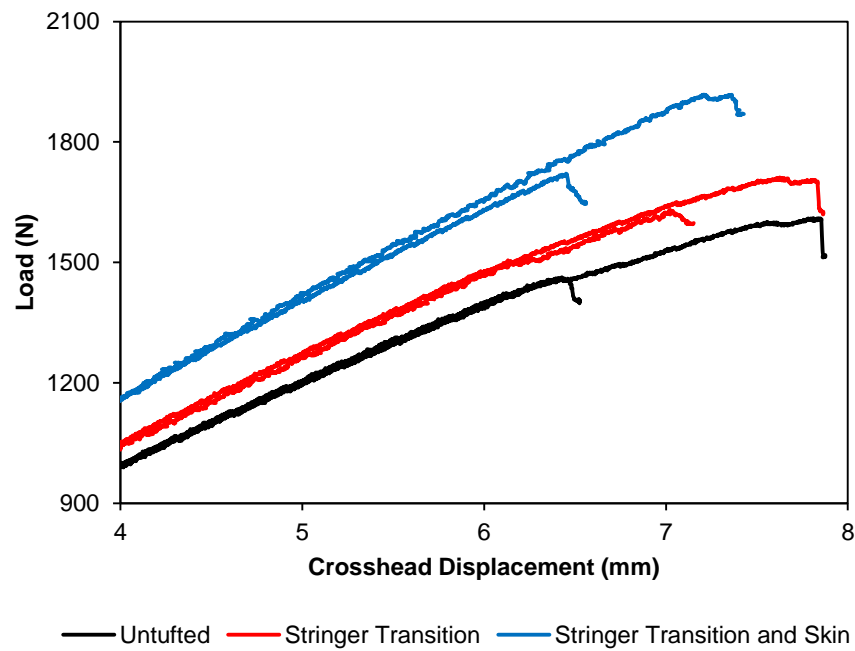
Figure 8: First failure load-displacement plot for skin-stringer tests.

The results of the bending tests that were stopped after first load drop are shown in Figure 8. Akin to the curves observed in Figure 6, increased tufting correlated to an increased joint stiffness and higher failure initiation loads. Averaging the peak loads of these curves shows that tufting the flange to skin transition (Figure 2b) resulted in an 8 % increase in peak load, further increasing to 16 % when tufting the stringer flange transition and adjacent skin to the stringer tip (Figure 2c). The performance increase from tufting is encouraging, but could be improved. Photographs of an untufted and tufted joint are shown in Figure 9. They reveal that inserting the tufts in the stringer to skin transition was successful at mitigating delamination at the stringer tip, but had no influence on the delamination that initiated in the flange to web transition of the stringer.

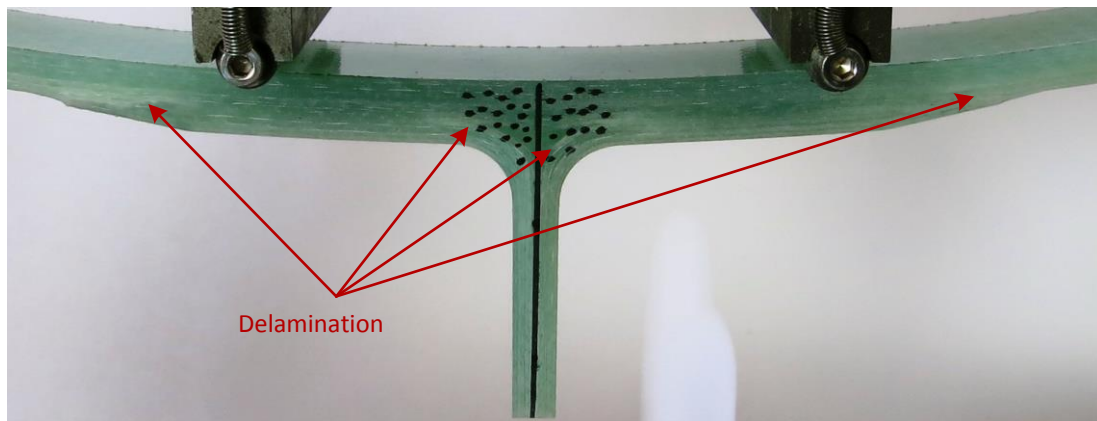
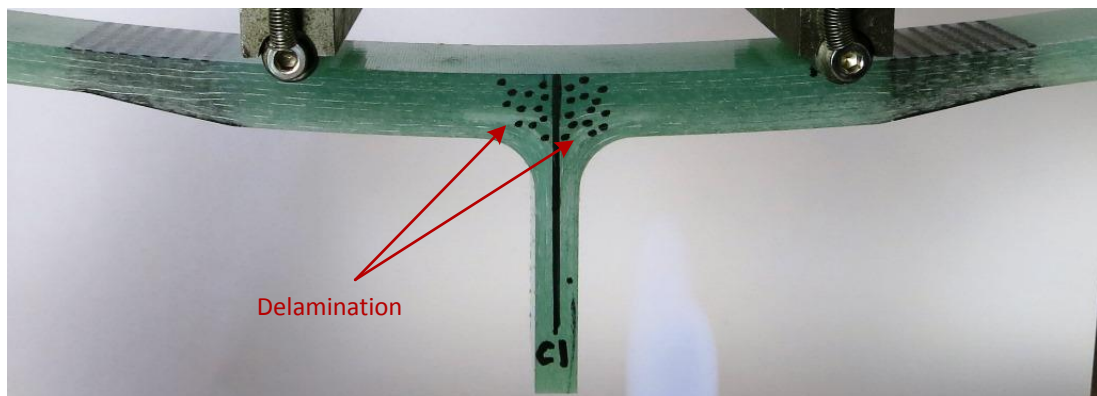
(a) Control

(b) Stringer transition and skin tufted

Figure 9: Delamination observed at first load drop during four-point bend testing.
